CITY OF BALTIMORE WET WEATHER CONSENT DECREE SMOKE AND DYED WATER TESTING FORM							Page 2 of 17					
;	Sewershed: OUTFALL		Company: REI/DRAYCO						Date: 09/29/2008			
Test Type: SMOKE			Ground Condition: Dry: X Damp:_ Wet:_						Supervisor: E.R.			
Manhole ID: S51II_028MH			Test ID: S1039-007									
Field Sketch : (Show all manholes with numbers, blower placement location, sandbag or isolation locations, street names, building addresses and locations, defect locations and photograph numbers)												
Defect		ind io	Source				Drainage					
No.	Address		Туре	Locatio	on	Sector	Area		Severity		Photo Number	
OB01	1403 N. ELLWOOD AVE.		03	07		02	1		03	S	1039-007_OB01-P01.jpg	
OB02	1407 N. ELLWOOD AVE.		03	07		02	1		03	S	1039-007_OB02-P01.jpg	
	1411 N. ELLWOOD AVE.		03	07		02	1		03	S	1039-007_OB03-P01.jpg	
	414 N. ELLWOOD AVE.		03	07		02	4	1	03	_	1039-007_OB04-P01.jpg	
	1425 N. ELLWOOD AVE.		03	07		02	1		03		1039-007_OB05-P01.jpg

CITY OF BALTIMORE SMOKE TESTING OBSERVATION SUMMARY OUTFALL SEWERSHED BALTIMORE CITY PROJECT 1039 REI/DRAYCO

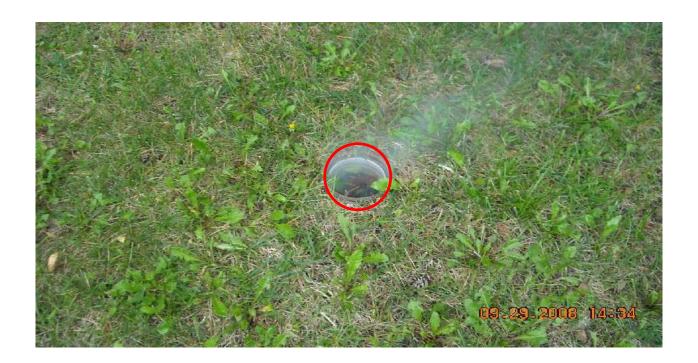
Photograph No: OB01-P01 Filename: S1039-007_OB01-P01.jpg

Location: 07 Yard - Front Severity: 03 Moderate Drainage Area: 1 ft²

Comments: An at-grade cleanout at 1403 N. Ellwood Ave. is missing a cap.

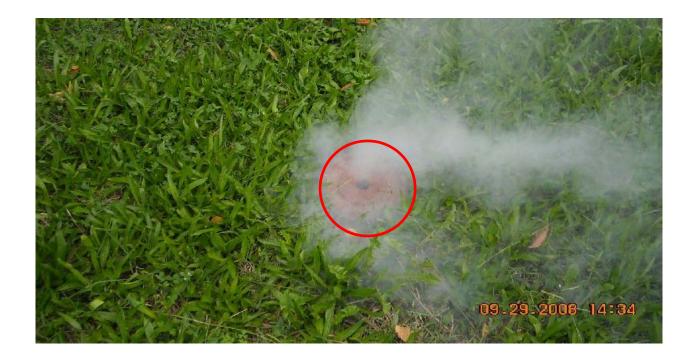
Photograph No: OB02-P01 Filename: S1039-007_OB02-P01.jpg

Location: 07 Yard - Front Severity: 03 Moderate Drainage Area: 1 ft²

Comments: An at-grade cleanout at 1407 N. Ellwood Ave. has a 10 lb weight for a cap.

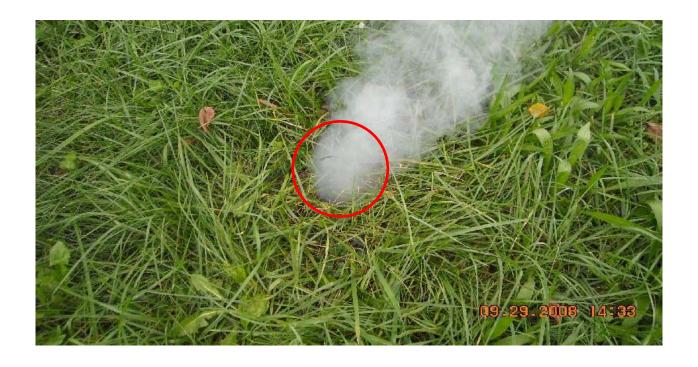
Photograph No: OB03-P01 Filename: S1039-007_OB03-P01.jpg

Location: 07 Yard - Front Severity: 03 Moderate Drainage Area: 1 ft²

Comments: An at-grade cleanout in the front yard of 1411 N. Ellwood Ave. is missing a cap.

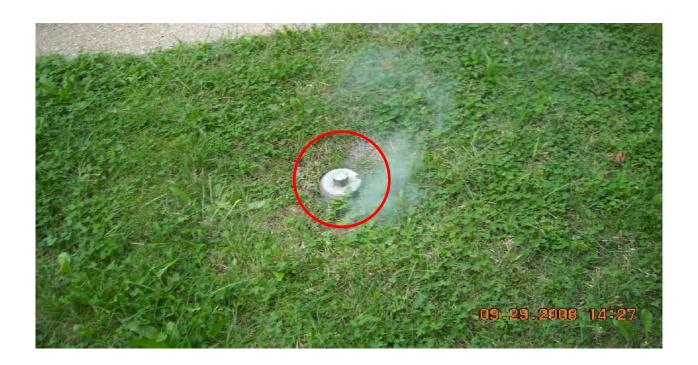
Photograph No: OB04-P01 Filename: S1039-007_OB04-P01.jpg

Location: 07 Yard - Front Severity: 03 Moderate Drainage Area: 4 ft²

Comments: An above grade cleanout in the front yard of 1414 N. Ellwood Ave. has a broken cap. Smoke also appears to be coming from its base.

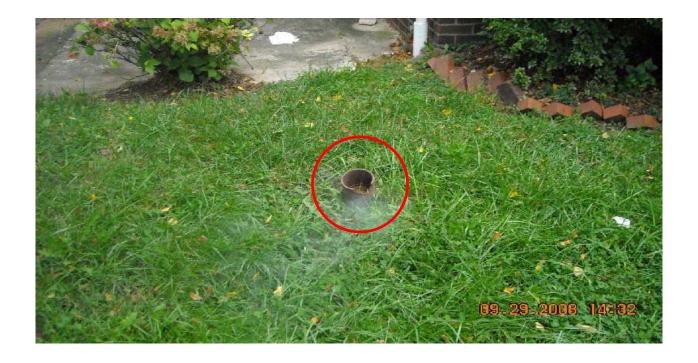
Photograph No: OB05-P01 Filename: S1039-007_OB05-P01.jpg

Location: 07 Yard - Front Severity: 03 Moderate Drainage Area: 1 ft Comments: An above grade cleanout in the front yard of 1425 N. Ellwood Ave. has a broken cap. Drainage Area: 1 ft²

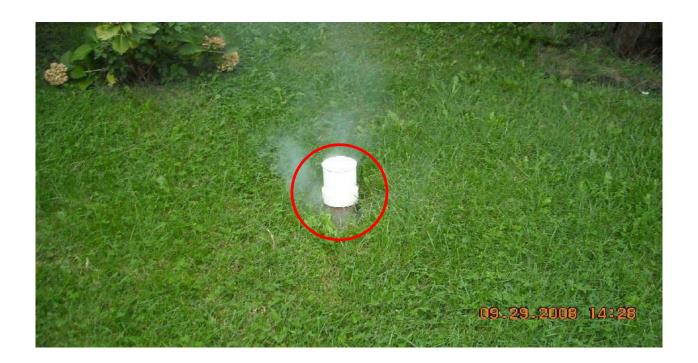
Photograph No: OB06-P01 Filename: S1039-007_OB06-P01.jpg

Location: 07 Yard - Front Severity: 03 Moderate Drainage Area: 1 ft Comments: An above grade cleanout in the front yard of 1428 N. Ellwood Ave. has a broken cap. Drainage Area: 1 ft²

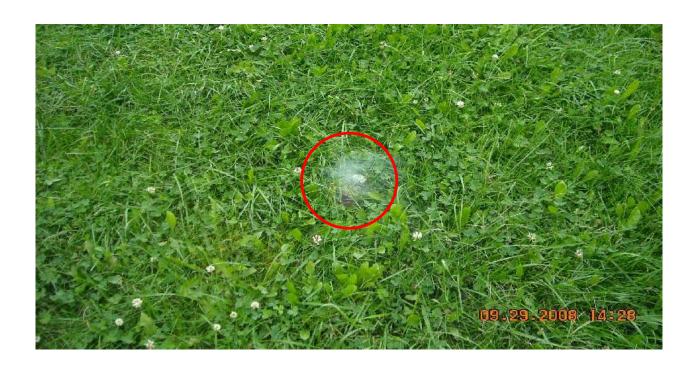
Photograph No: OB07-P01 Filename: S1039-007_OB07-P01.jpg

Location: 07 Yard - Front Severity: 03 Moderate Drainage Area: 1 ft Comments: An above grade cleanout in the front yard of 1428 N. Ellwood Ave. has a broken cap. Drainage Area: 1 ft²

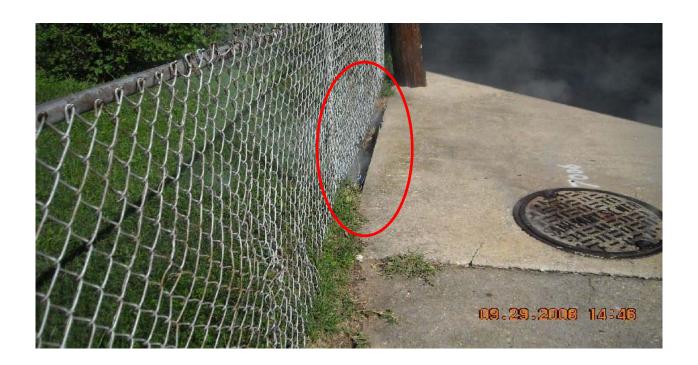
Photograph No: OB08-P01 Filename: S1039-007_OB08-P01.jpg

Location: 12 Alley Severity: 03 Moderate Drainage Area: 16 ft²

Comments: Smoke is coming from a hole alongside the alley behind 3021 E. Federal St.

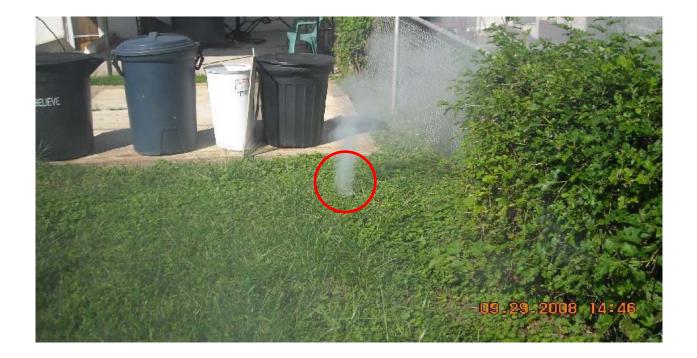
Photograph No: OB09-P01 Filename: S1039-007_OB09-P01.jpg

Location: 08 Yard - Back Severity: 03 Moderate Drainage Area: Comments: An above grade cleanout in the back yard of 3021 E. Federal St. is missing a cap. Drainage Area: 1 ft²

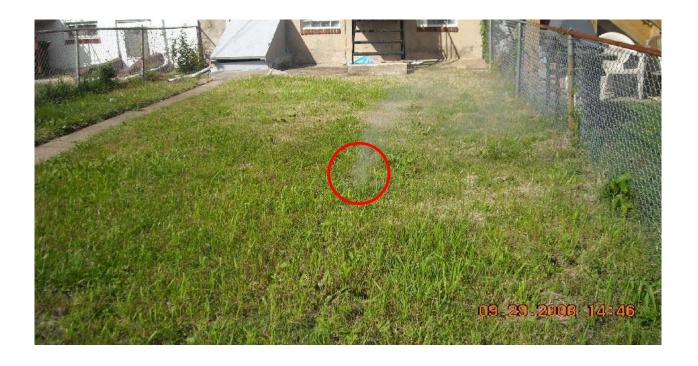
Photograph No: OB10-P01 Filename: S1039-007_OB10-P01.jpg

Location: 08 Yard - Back Severity: 03 Moderate Drainage Area: 1 ft²

Comments: Smoke is coming from a broken cleanout in the back yard of 3025 E. Federal St.

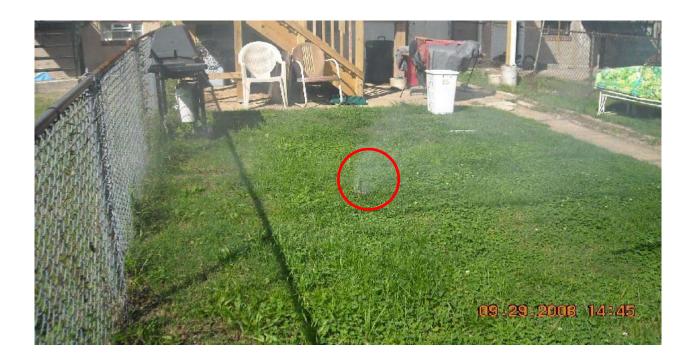
Photograph No: OB11-P01 Filename: S1039-007_OB11-P01.jpg

Location: 08 Yard - Back Severity: 03 Moderate Drainage Area: 1 ft² Comments: Smoke is coming from a broken above grade cleanout in the back yard of 3027 E. Federal St.

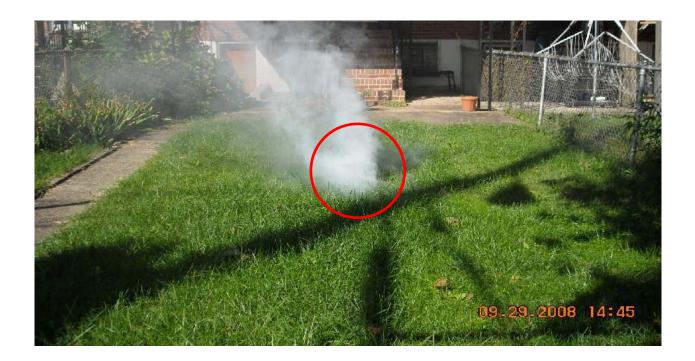
Photograph No: OB12-P01 Filename: S1039-007_OB12-P01.jpg

Location: 08 Yard - Back Severity: 03 Moderate Drainage Area: 1 ft²

Comments: A cleanout in the back yard of 3031 E. Federal St. is missing a cap.

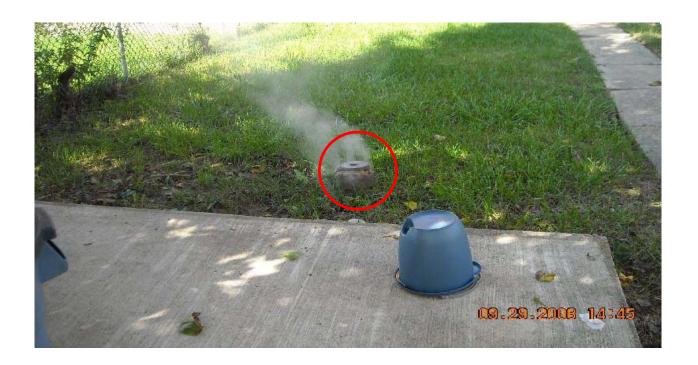
Photograph No: OB13-P01 Filename: S1039-007_OB13-P01.jpg

Location: 08 Yard - Back Severity: 03 Moderate Drainage Area: 1 ft² Comments: Smoke is coming from a broken above grade cleanout in the back yard of 3033 E. Federal St.

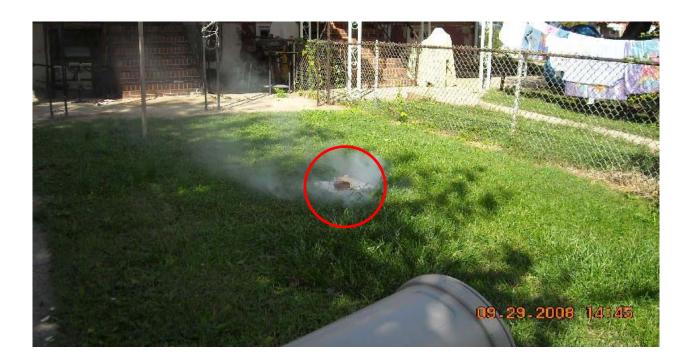
Photograph No: OB14-P01 Filename: S1039-007_OB14-P01.jpg

Location: 08 Yard - Back Severity: 03 Moderate Drainage Comments: Smoke is coming from this cleanout in the back yard of 3035 E. Federal St.

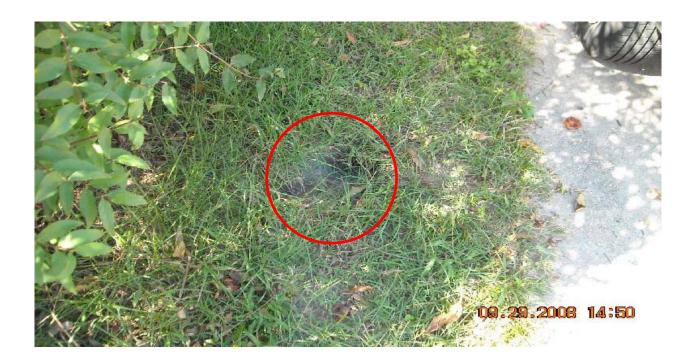
Photograph No: OB15-P01 Filename: S1039-007_OB15-P01.jpg

Location: 08 Yard - Back Severity: 03 Moderate Drain.

Comments: Smoke is coming from this hole in the back yard of 3037 E. Federal St. Drainage Area: 4 ft²
